ROAD 27 OVERCROSSING PROGRESS UPDATE

Joe Hedges, CHSRA

January 21, 2021

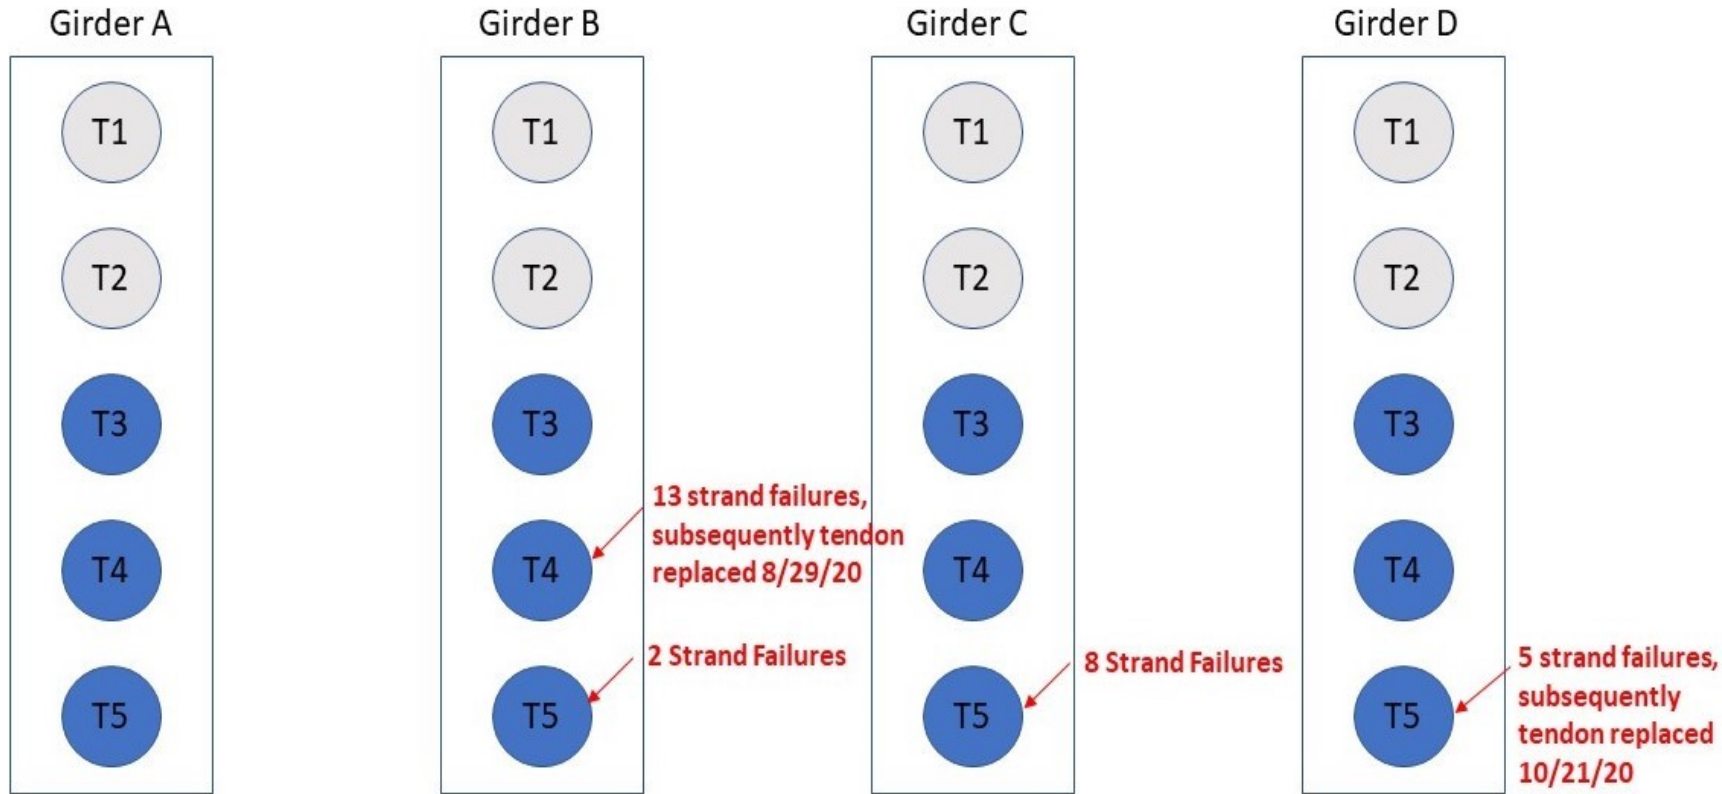
Abutment # 1 (South Abutment looking North)

- 28 strand failures 8/13/20 – 01/18/21 (3 additional failures in Girder C, T5)
